Clarence Darrow Bridge

History and Limited Condition Assessment

Limited Condition Assessment
WJE No. 2023.7951

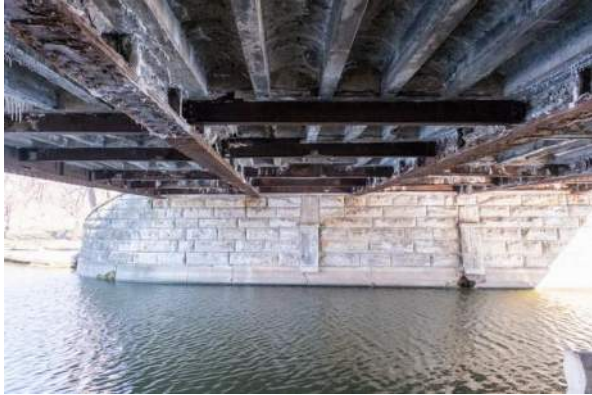
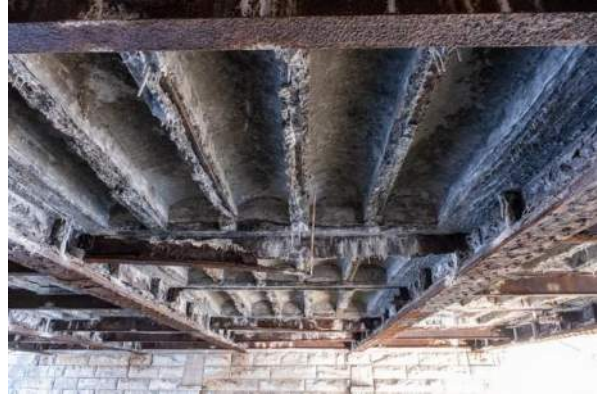
The steel superstructure of the bridge exhibits severe corrosion and loss of section. The steel framing and concrete deck are in poor condition. The riveted steel girders and floor beams exhibit advanced corrosion, with rust holes and severe section loss. The concrete deck shows evidence of advanced freeze-thaw deterioration and water leakage. The existing superstructure is not the pony truss that existed when the bridge was first designed and constructed; however, the existing superstructure was installed within the period of significance for the historic structure. If the existing steel assembly were to be retained, extensive repair and localized replacement would be required. Modifications to the existing steel structure would be needed to accommodate the loading that we understand will be required (i.e., pedestrian and emergency vehicle traffic). Given the condition of the existing steel structure and required modifications for continued use, repair may not be determined feasible. If the steel superstructure is replaced, the design could reflect the historic character of the bridge circa 1895; consideration will be needed during design development to determine the extent to which a new concrete superstructure would convey this character. If the superstructure is replaced, the existing structure should first be documented to record existing construction, and the Chicago Park District may want to retain selected components of the steel structure for archival purposes.

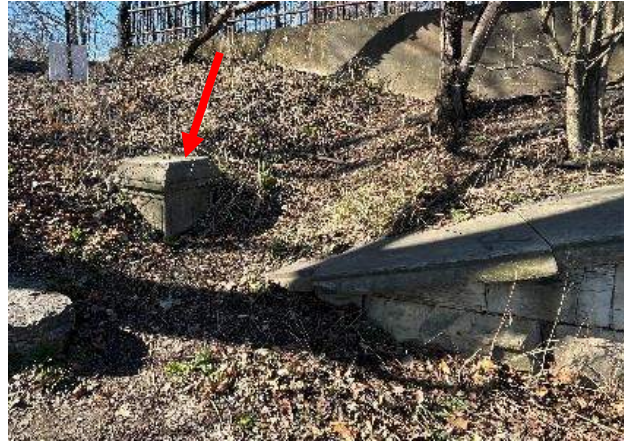
Figure 41. The pier, finial, and the lower portion of west abutment wall are partially covered with soil.

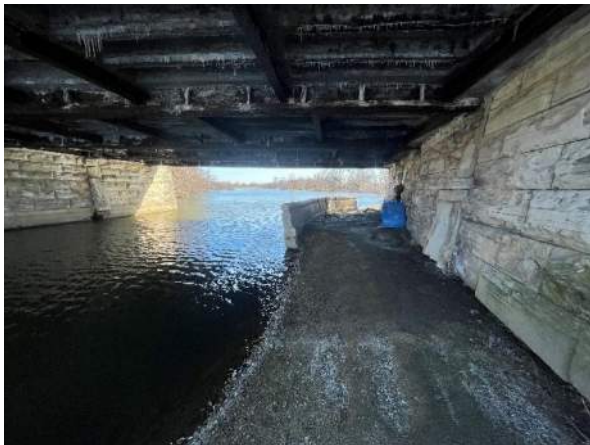
Figure 42. Area where walk appears to have been washed out and the retaining wall sections are missing; view looking south.

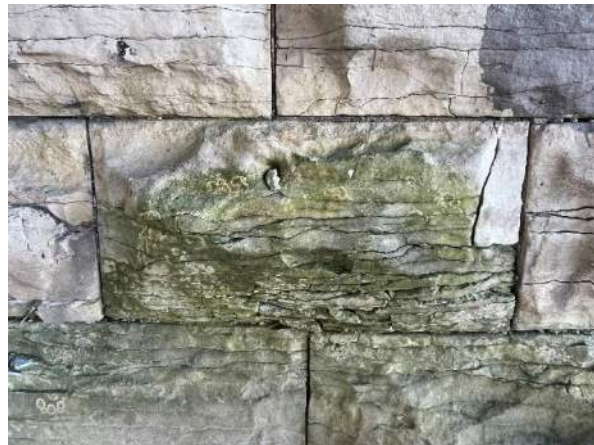
- Some of the stone cladding units at the abutments are visibly cracked and/or sounded fractured when tapped with a mallet. In general, the distress appears to be at the surface of the stone and the underlying stone substrate is sound; however, there are a number of units with extensive horizontal cracking and unsound material extending further into the depth of the stone (Figure 43 and Figure 44).

Figure 43. Severely cracked stone unit at the west abutment wall.

grade walls should be confirmed, as well as the condition of the masonry rubble observed behind the facing units. If the abutments can be retained and repaired in place, displaced units should be removed and reset. A close-up visual assessment should be performed, including sounding of individual units, to determine if measures such as installation of dutchman or crack repairs is required.

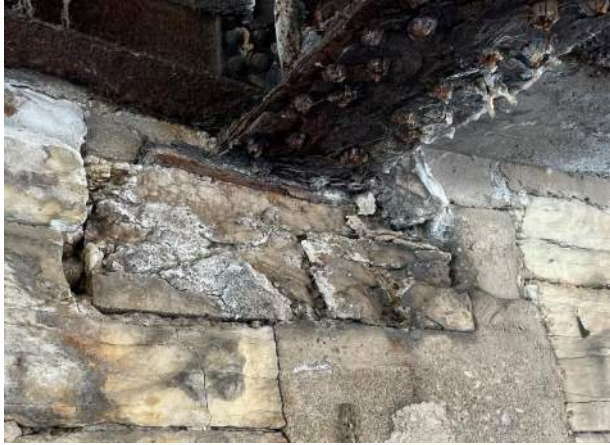
Figure 44. Severely spalled and deteriorated stone unit below a steel framing member at the west abutment wall.

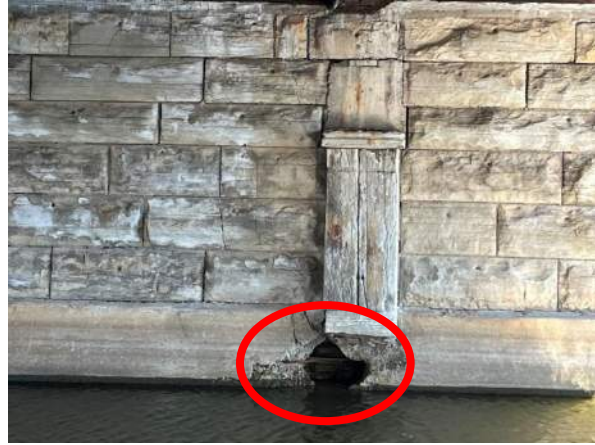
- A reinforced concrete jacket exists at the east abutment, which appears to have been added to arrest and contain undermining of the east abutment wall at its base. The jacket was placed around the haunch above and was therefore constructed after the haunch. The concrete jacket has two large spalls that extend the full depth of the jacket (Figure 45). One of the spalls aligns with the stone haunch and the underlying rubble masonry backup is exposed to view. In addition to the spalls, vertical cracking is present that aligns with joints in the stone cladding (Figure 46).

Figure 45. Large hole in the reinforced concrete jacket below a haunch in the east abutment wall.

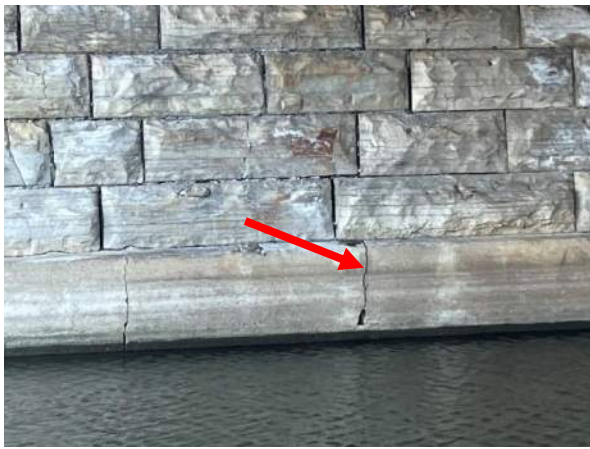
Figure 46. Vertical crack in the concrete foundation of the east abutment wall.

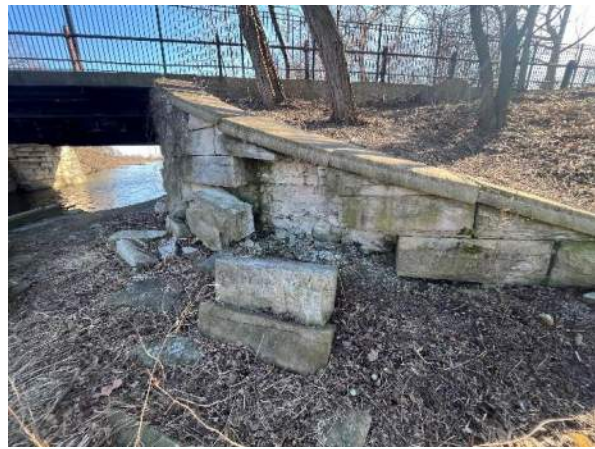
- Portions of the stone cladding at the west abutment wall have collapsed, especially at the north end of the west abutment wall where a portion of the wall is unsupported, and the rubble stone backup masonry is exposed to view (Figure 47). The rubble foundation, if present, appears to have deteriorated at this location (Figure 48).

Figure 47. Displaced stone units at the south end of the east abutment. Note the exposed stone rubble wall construction behind the displaced units.

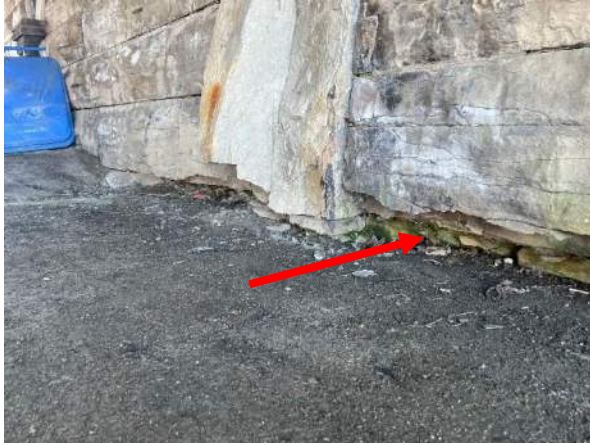
Figure 48. Undercut portion of west abutment wall where there is a gap below the stone cladding. The underlying rubble stone backup is exposed to view.

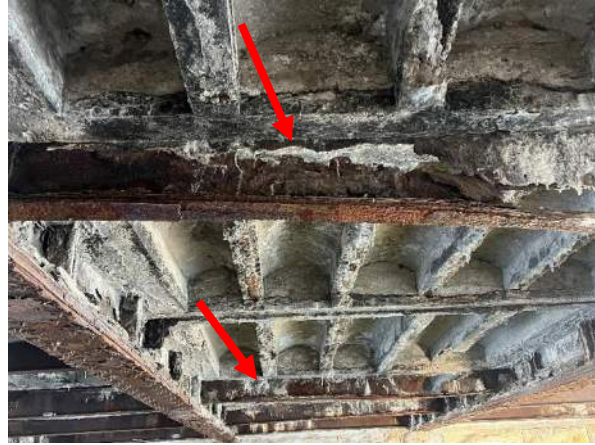
- The steel structure below the concrete deck slab is severely corroded. Nearly all of the framing members exhibit full section loss of the steel or are no longer anchored to the structure due to loss of section through corrosion (Figure 49).
- The concrete deck is in poor condition and exhibits widespread cracking and spalling of the concrete, specifically at the ribs, where the embedded steel is observed to be corroded (Figure 50) is also extensive cracking as well as large calcium carbonate deposits hanging from the underside of the deck, indicative of water ingress through the slab (Figure 51).
- Some of the intermediate rail posts and the horizontal rails of the railing have been replaced with modified steel I-beams (Figure 52).

Figure 49. Corrosion and total loss of section at steel channels.

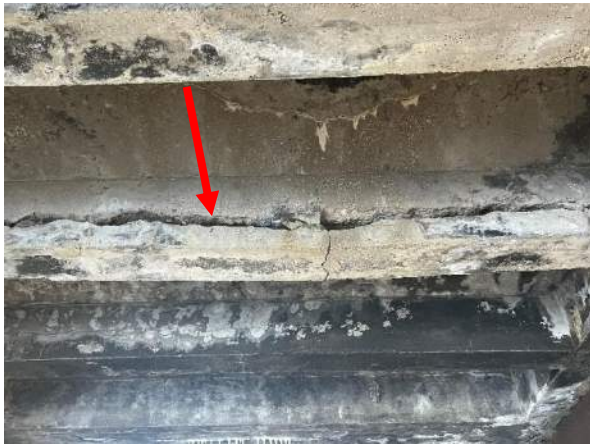
Figure 50. Cracking along the bottom of the concrete rib aligned with bottom flange of embedded steel beam.

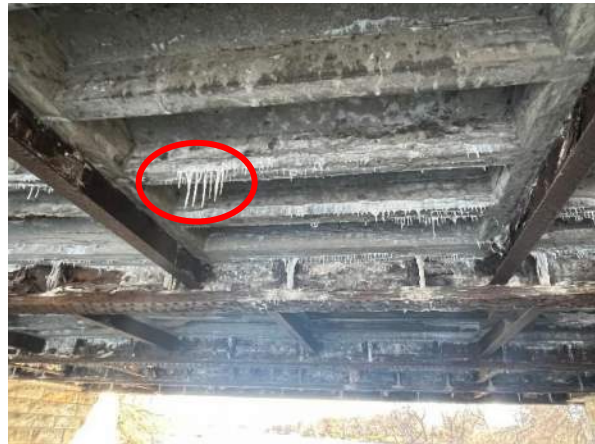
Figure 51. White deposits hanging from the underside of the slab indicative of water ingress through the slab.

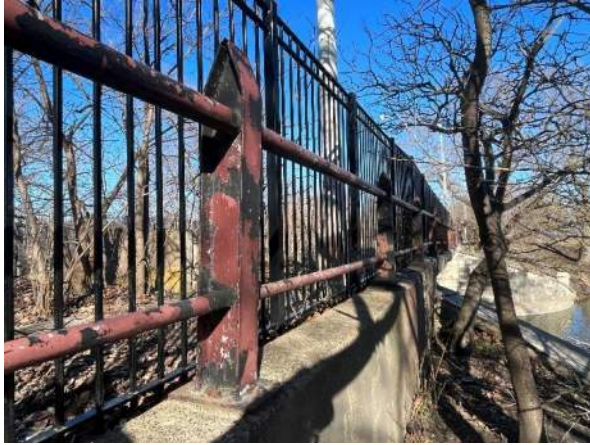
Figure 52. Typical replacement post.

The railings include components that appear to be part of the historic fabric as well as replacement pieces. The original rail elements are iron and do not exhibit extensive cracking. While a few original elements have been replaced, many remain and can be salvaged and restored for reuse. This process would involve dismantlement, cleaning to remove existing coatings, removal of corrosion, localized repairs as needed, and preparation and coating with a rust-inhibitive coating system. New elements matching the original pieces will need to be fabricated to replace existing non-original elements.
