Clarence Darrow Bridge

History and Limited Condition Assessment

Limited Condition Assessment
WJE No. 2023.7951

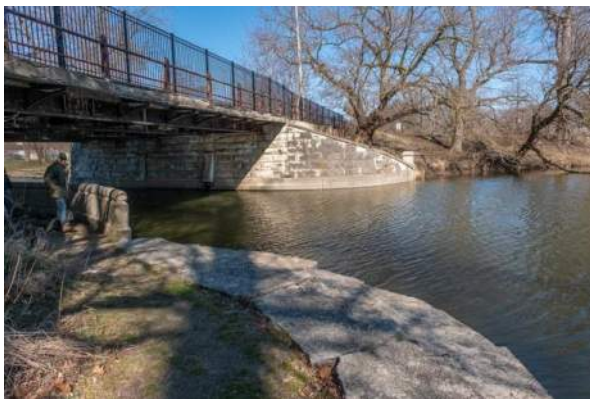
Figure 29. View of the east abutment, as seen from the west abutment.

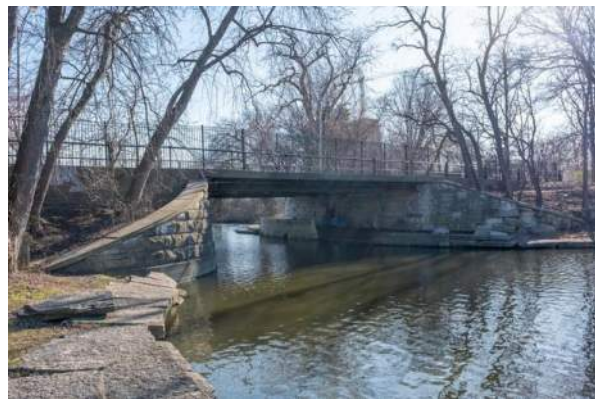
Figure 30. View of the west abutment, as seen from the north approach to the east abutment.

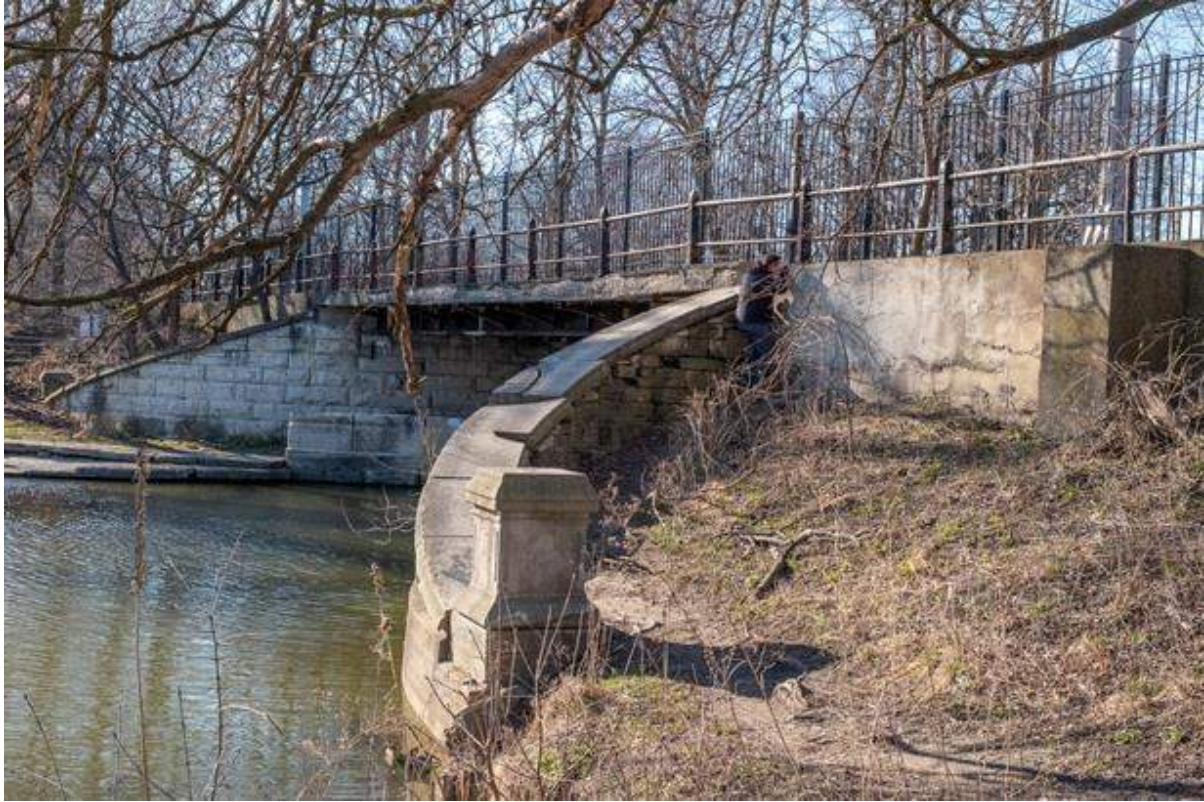
Figure 31. View of the east abutment from the southeast, with the south end of the west abutment visible beyond. Note the masonry on the land-facing side of the east abutment. The masonry is similar to the rubble wall exposed where limestone units have been displaced on the water-facing side at the north end of the west abutment and, to a lesser degree, at the water-facing side at the south end of the east abutment.

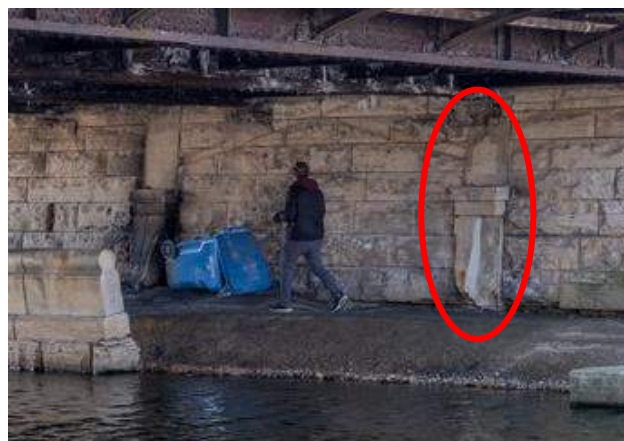
Figure 35. One of two stone haunches on the west abutment of the bridge that historically supported one end of a pony truss.

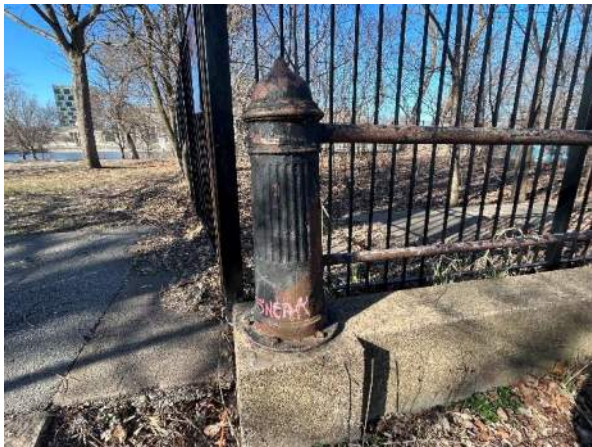
A cast iron perimeter railing extends along the length of the bridge deck and consists of a surface-mounted fluted round post with a finial at either end of the bridge (Figure 38). Fluted rectangular intermediate posts with a pointed arch cap are positioned along the length of the deck (Figure 39). Round upper and lower rails span between the posts.

Figure 38. Cast iron post at end of railing.

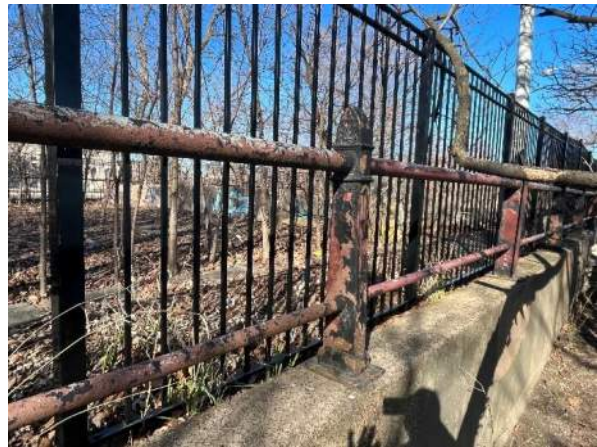
Figure 39. Typical cast iron railing section and post.

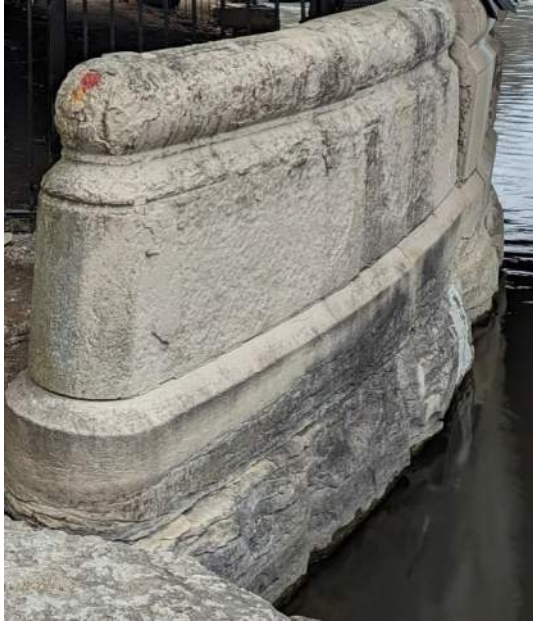
Figure 40. Stone retaining wall at edge of water along west abutment, south end.

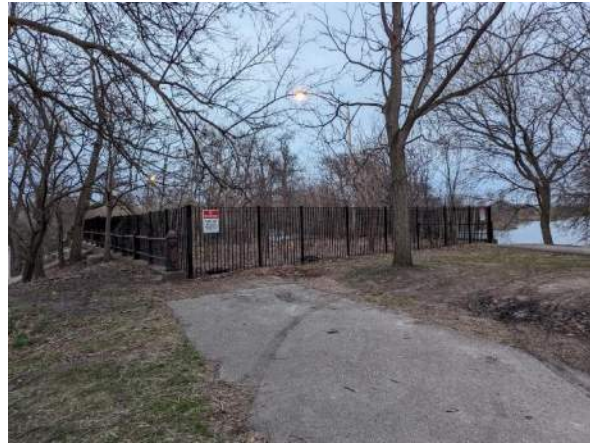
Access to the bridge deck is precluded by a painted steel fence that surrounds the entire bridge at deck level, exterior to the railings along the north and south sides and across the width of the bridge to the east and west of the bridge deck (Figure 53). After the site visit for this study was completed in March 2024, new fence and gate assemblies were installed at the north and south ends of the west abutment to prevent access to the area along the walkway beneath the bridge, adjacent to the water (Figure 54 and Figure 55).

Figure 53. Overall view of the fence enclosing the bridge. This fence was in place during the site visit for this study in March 2024. (Source: Eric Allix Rogers, April 2024)

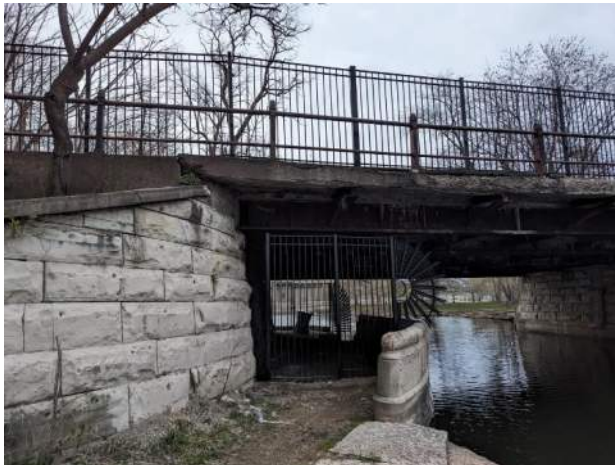
Figure 54. Following the site visit in March 2024, a fence and gate assembly was installed at either end of the west abutment, preventing access to the area under the bridge. View of the new installation at the south end of the west abutment, looking north. (Source: Eric Allix Rogers, April 2024)

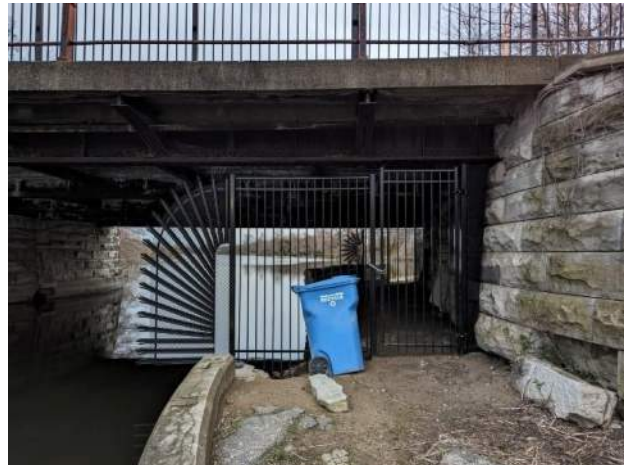
Figure 55. View of the new installation at the north end of the west abutment, looking south. (Source: Eric Allix Rogers, April 2024)
